UNDERWATER BRIDGE INSPECTION REPORT

STRUCTURE NO. 7100

MINNESOTA RIVER

JOB NO. 3512 (CEI 130)

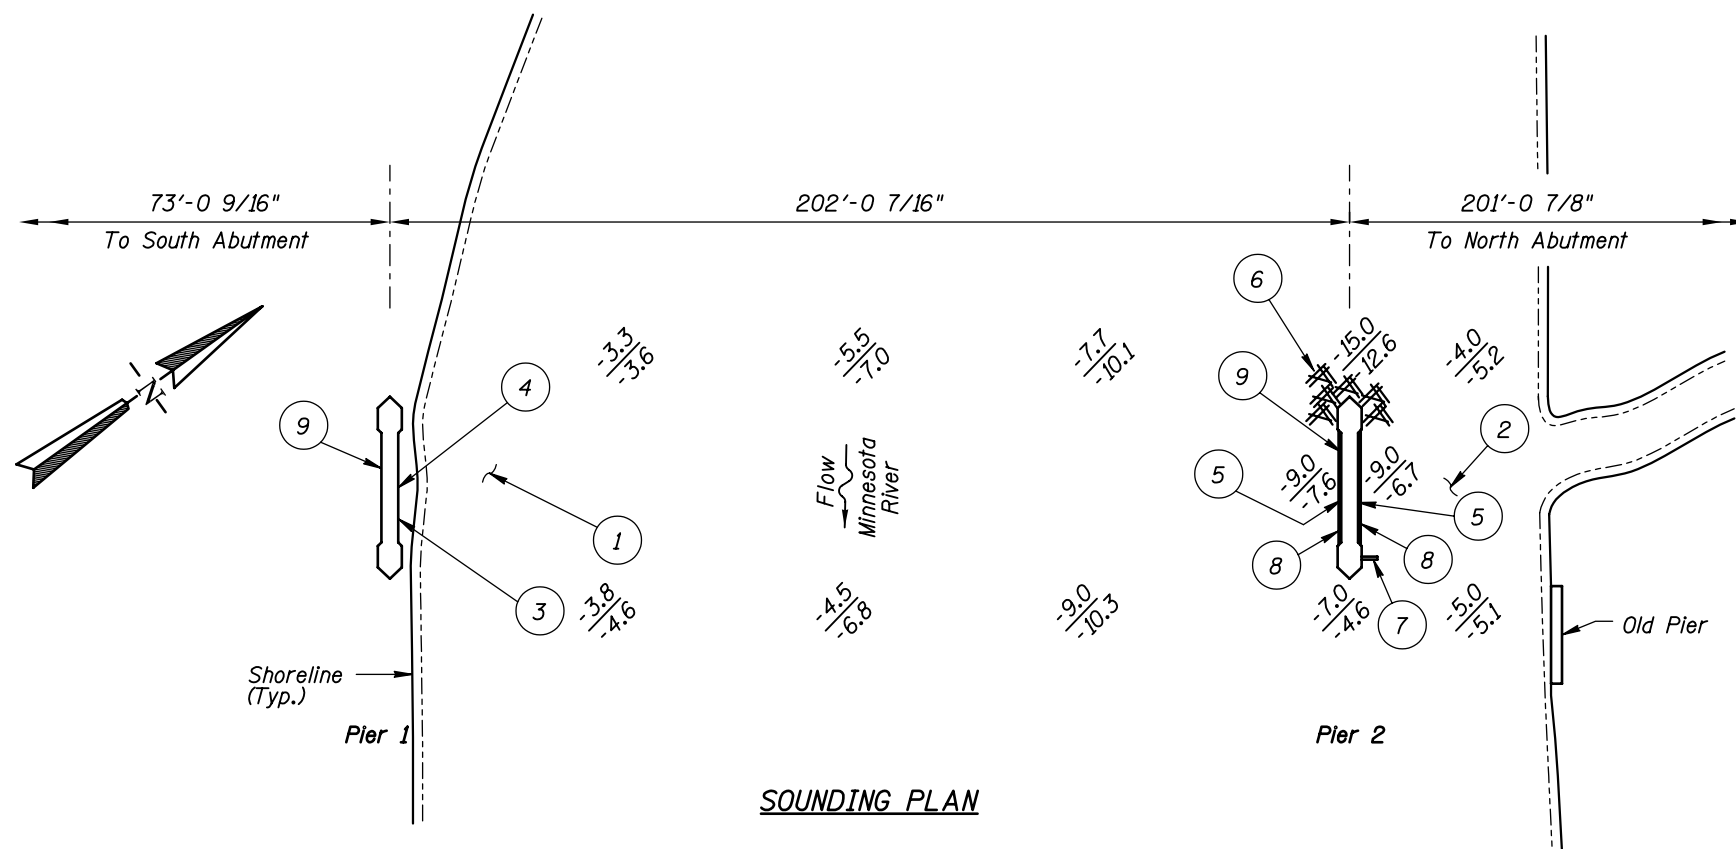
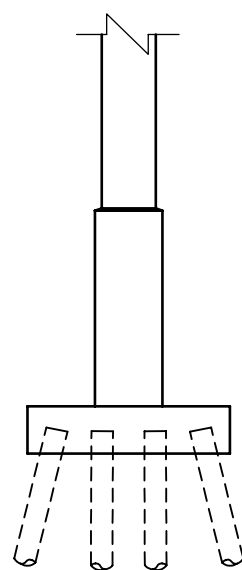
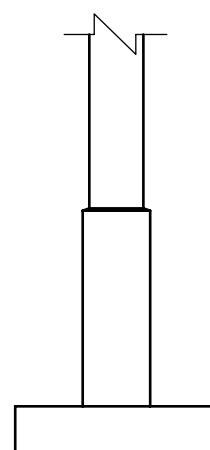
SOUNDING PLAN

- 1 The channel bottom consisted of soft silty clay with up to 2 feet of probe rod penetration.
- 2 The channel bottom consisted of cobbles and riprap except at the downstream nose which consisted of silty clay with up to 3 inches of penetration.

- 3 Minor areas of section loss with up to a 1/2 inch penetration were observed at Pier 1 from the groundline to 5 feet above the groundline with areas of exposed reinforcing steel.

- 4 A vertical crack, up to 1/8 inch wide, was observed extending from the top of the pier cap to the groundline.
- 5 A vertical crack, up to 1/8 inch wide, was observed extending from the top of the pier cap to 2 feet below the waterline on each face of the pier.

- 6 A moderate accumulation of timber debris, with pieces up to 1 foot in diameter, was observed at the upstream end of Pier 2 extending from the channel bottom to 6 feet above the channel bottom. Depth of water at upstream nose indicates possible footing exposure; however, drift precluded the confirming of any exposure.

- 7 Two horizontal steel struts were observed extending from the north face of the downstream column 6 inches above the channel bottom.
- 8 A 6-inch-wide step was observed five feet below the waterline extending along each face of the pier shaft between the columns at Pier 2.

- 9 Random areas of poor consolidation, map cracking, and areas of section loss up to 1 inch in diameter were observed at Piers 1 and 2.

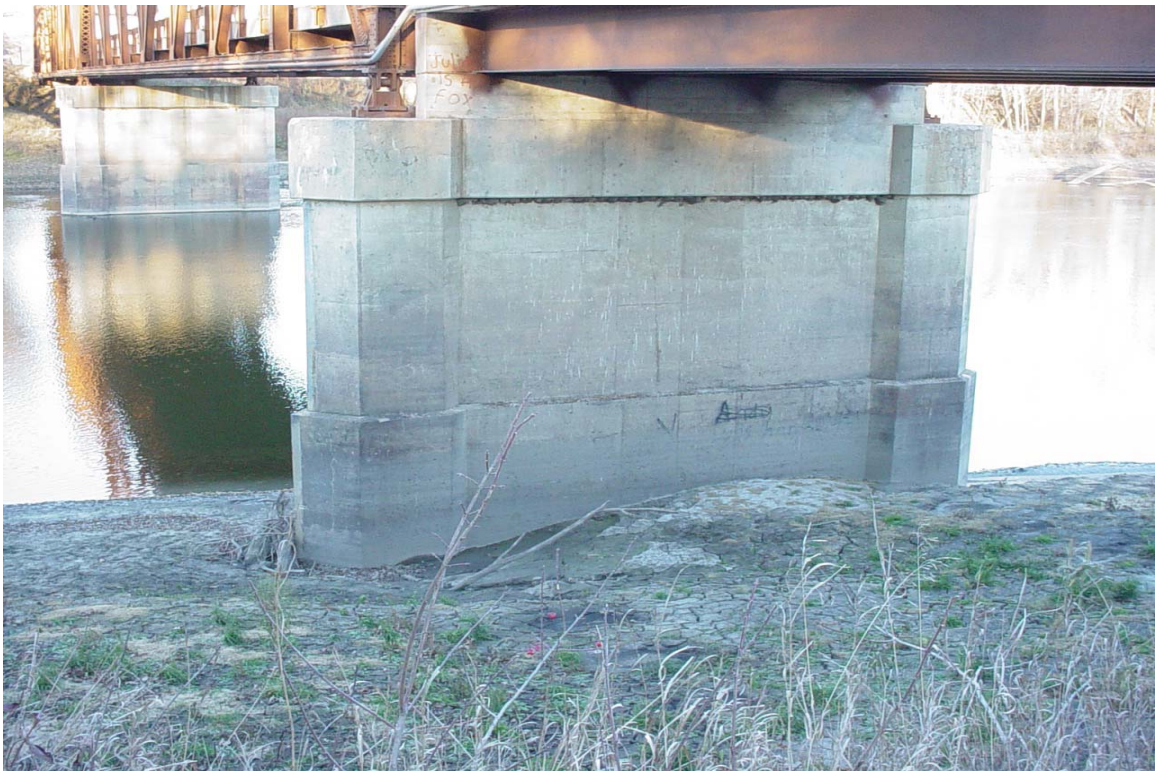
Photograph 2. View of Pier 1, Looking East.

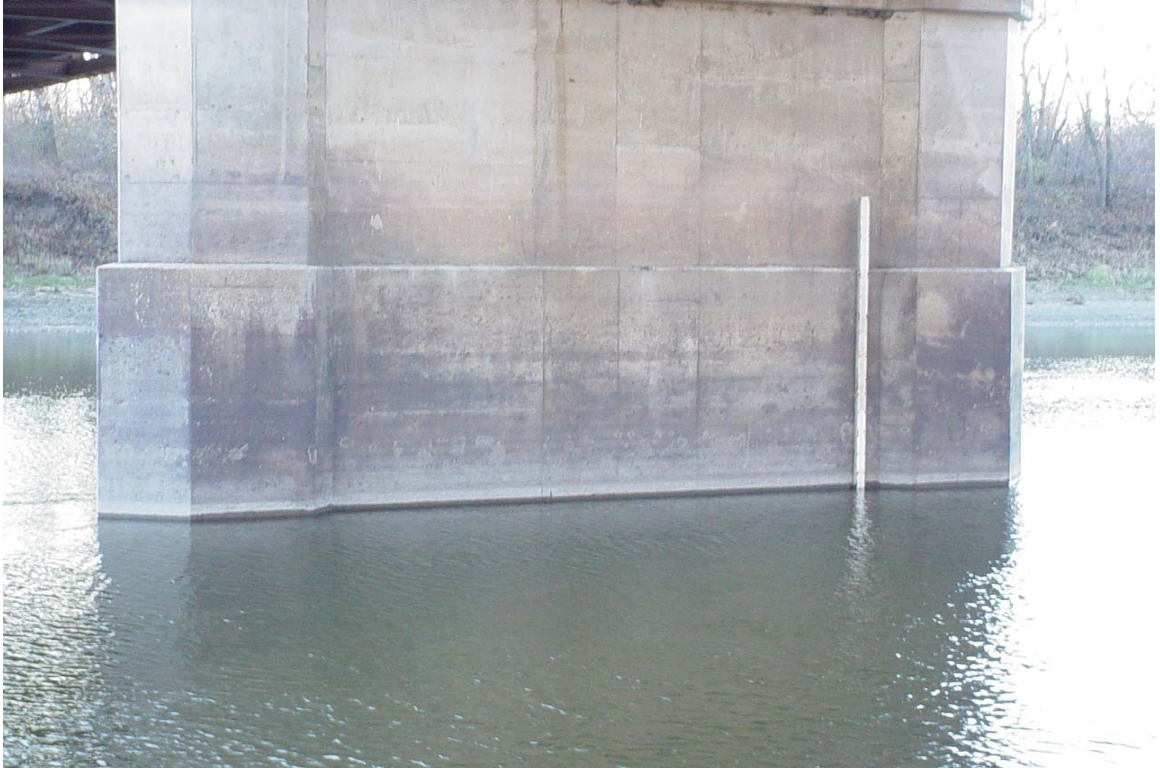
Photograph 3. View of Pier 2, Looking West.

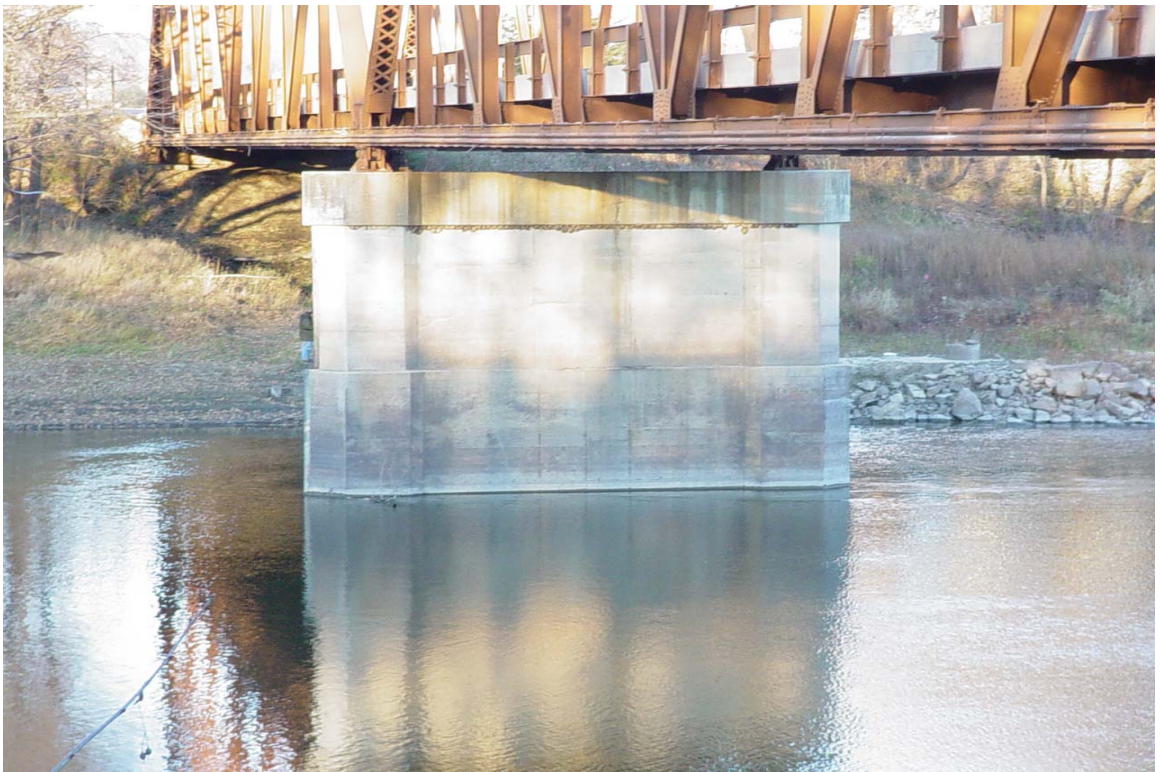
Photograph 4. View of Pier 2, Looking East.
